MISCELLANEOUS PAPER S-71-27

DESIGN OF UNSURFACED SOIL FACILITIES FOR OPERATIONS OF C-5A AIRCRAFT

D. M. Ladd, V. C. Barber

Conducted by U. S. Army Engineer Waterways Experiment Station, Vicksburg, Mississippi

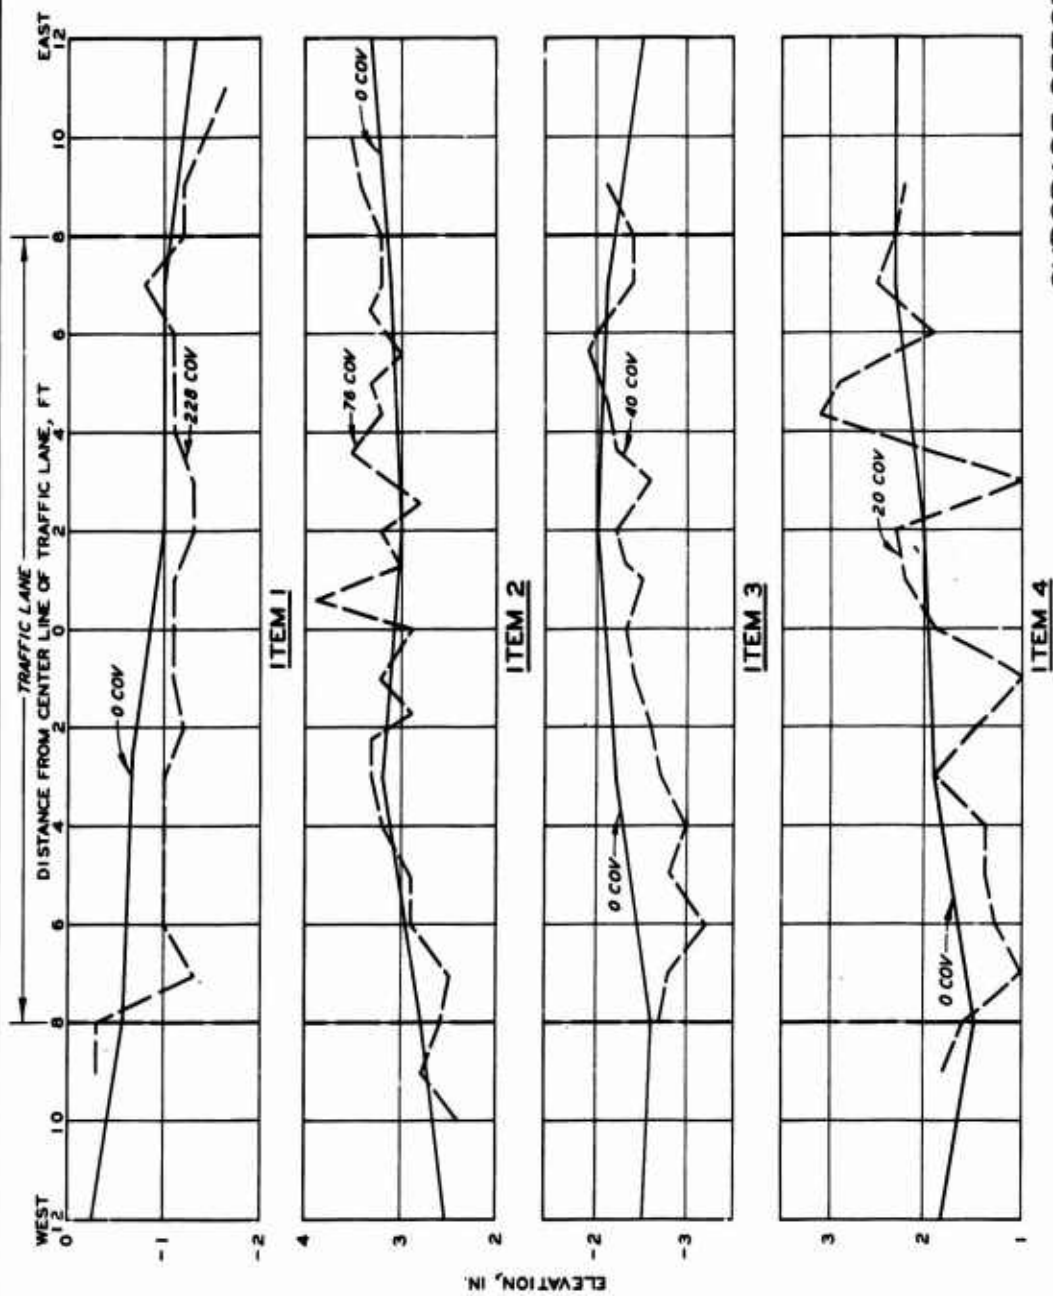
SUBGRADE DEFORMATIONS
TEST SECTION 2, LANE 2

39. Subgrade deformation (items 1-4). Typical cross sections of the interface of the two soil layers in each item are shown in plate 11. These data indicate that the failures noted in the surface of each item were contributed to by deformation in the soil below the interface of the two layers.

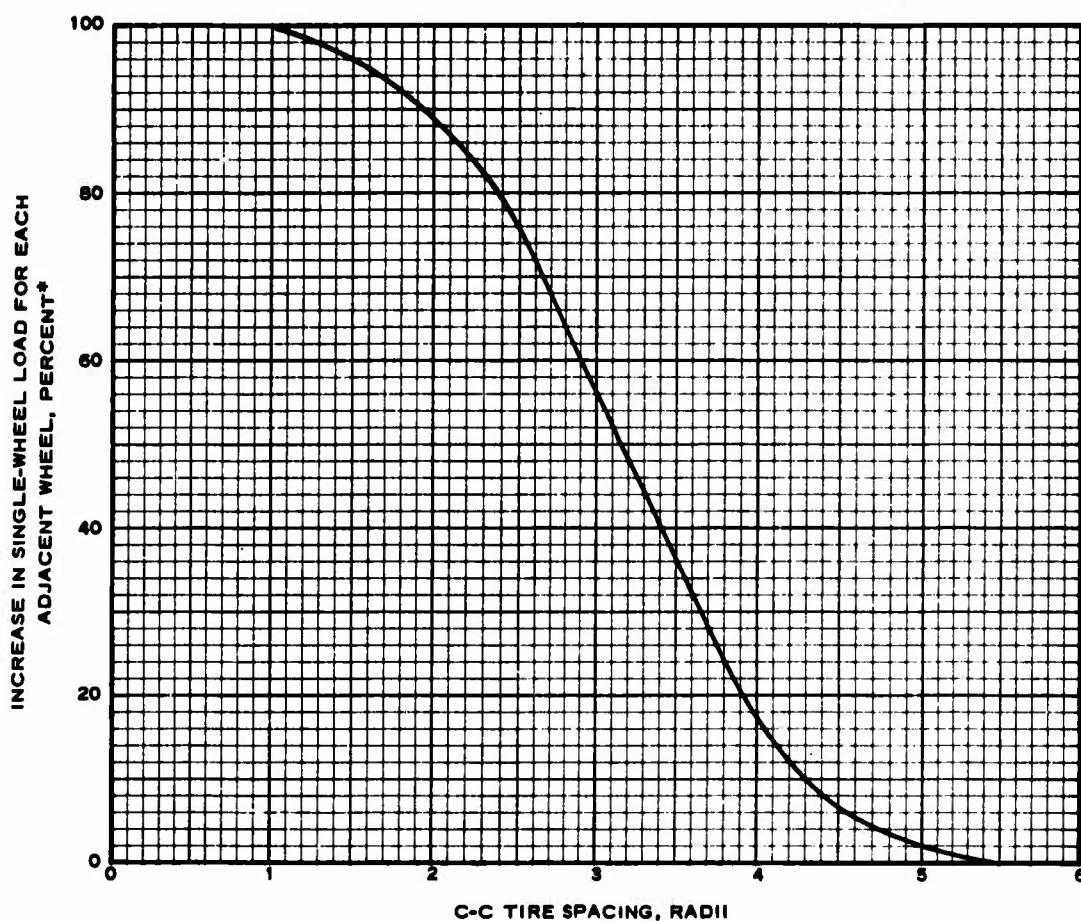
EQUIVALENT SINGLE-WHEEL
LOAD-ADJUSTMENT CURVE
FOR UNSURFACED SOILS

43. The ESWL's were determined by use of plate 13. This plate shows wheel spacing versus the percent influence that one wheel has on another. The wheel spacing is expressed in radii and is determined by dividing the wheel spacing in inches by the radius of a circle having the same area as the contact area of one tire. The percent influence that one wheel has on another represents the amount that one wheel load

must be increased to determine the ESWL. For the C-5A, the least spacing between two wheels is 34 in. Since the contact area of one tire is 195 sq in., the radius of this area is $\sqrt{195/\pi}$, or 7.89 in. The spacing between the tires is, therefore, $34/7.89 = 4.31$ -in. radii. From plate 13, the influence of one wheel on the other is found to be 10 percent. The ESWL is, therefore, $21,000 \text{ lb} \times 1.10 = 23,100 \text{ lb}$. The other wheels of the assembly are spaced so that they have no influence on the ESWL.

* INCREASE IN LOAD ON A SINGLE WHEEL OF A MULTIPLE-WHEEL GEAR TO ACCOUNT FOR EFFECTS OF ADJACENT WHEELS OF THE MULTIPLE-WHEEL GEAR IN ARRIVING AT AN EQUIVALENT SINGLE-WHEEL LOAD.

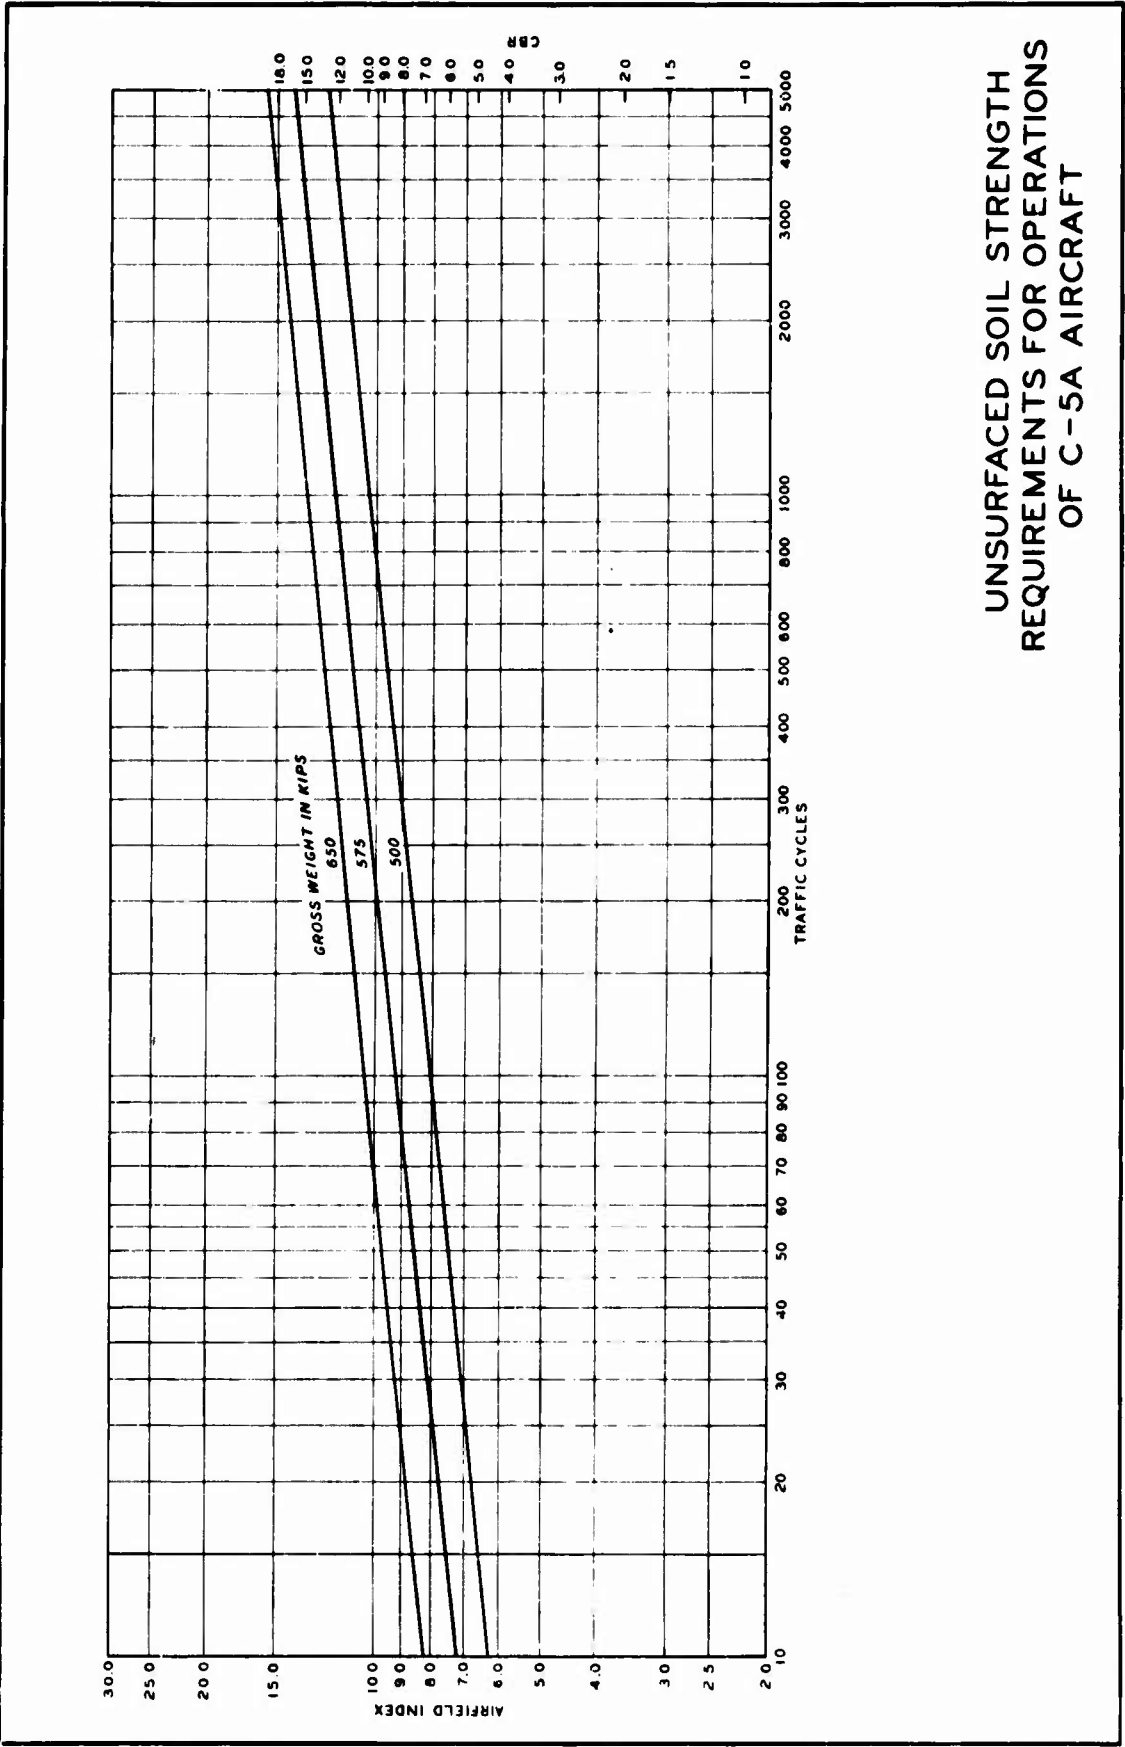
UNSURFACED SOIL STRENGTH
REQUIREMENTS FOR OPERATIONS
OF C-5A AIRCRAFT

45. Specific design curves for determining the soil surface strength required to support operations of C-5A are shown in plate 15. These curves relate traffic cycles to CBR and airfield index. The nomograph, plate 12, presents traffic in terms of coverages. However, traffic cycle, as used in plate 15, is a more common term and is related to coverages by a cycles per coverage factor of 0.69. Also, soil strength, in a military situation, is normally measured in terms of airfield index, not CBR; therefore, the airfield index is shown along with CBR in plate 15.
